Balanced APPROACH

Kansas home's exterior remodel creates visual consistency for enhanced curb appeal

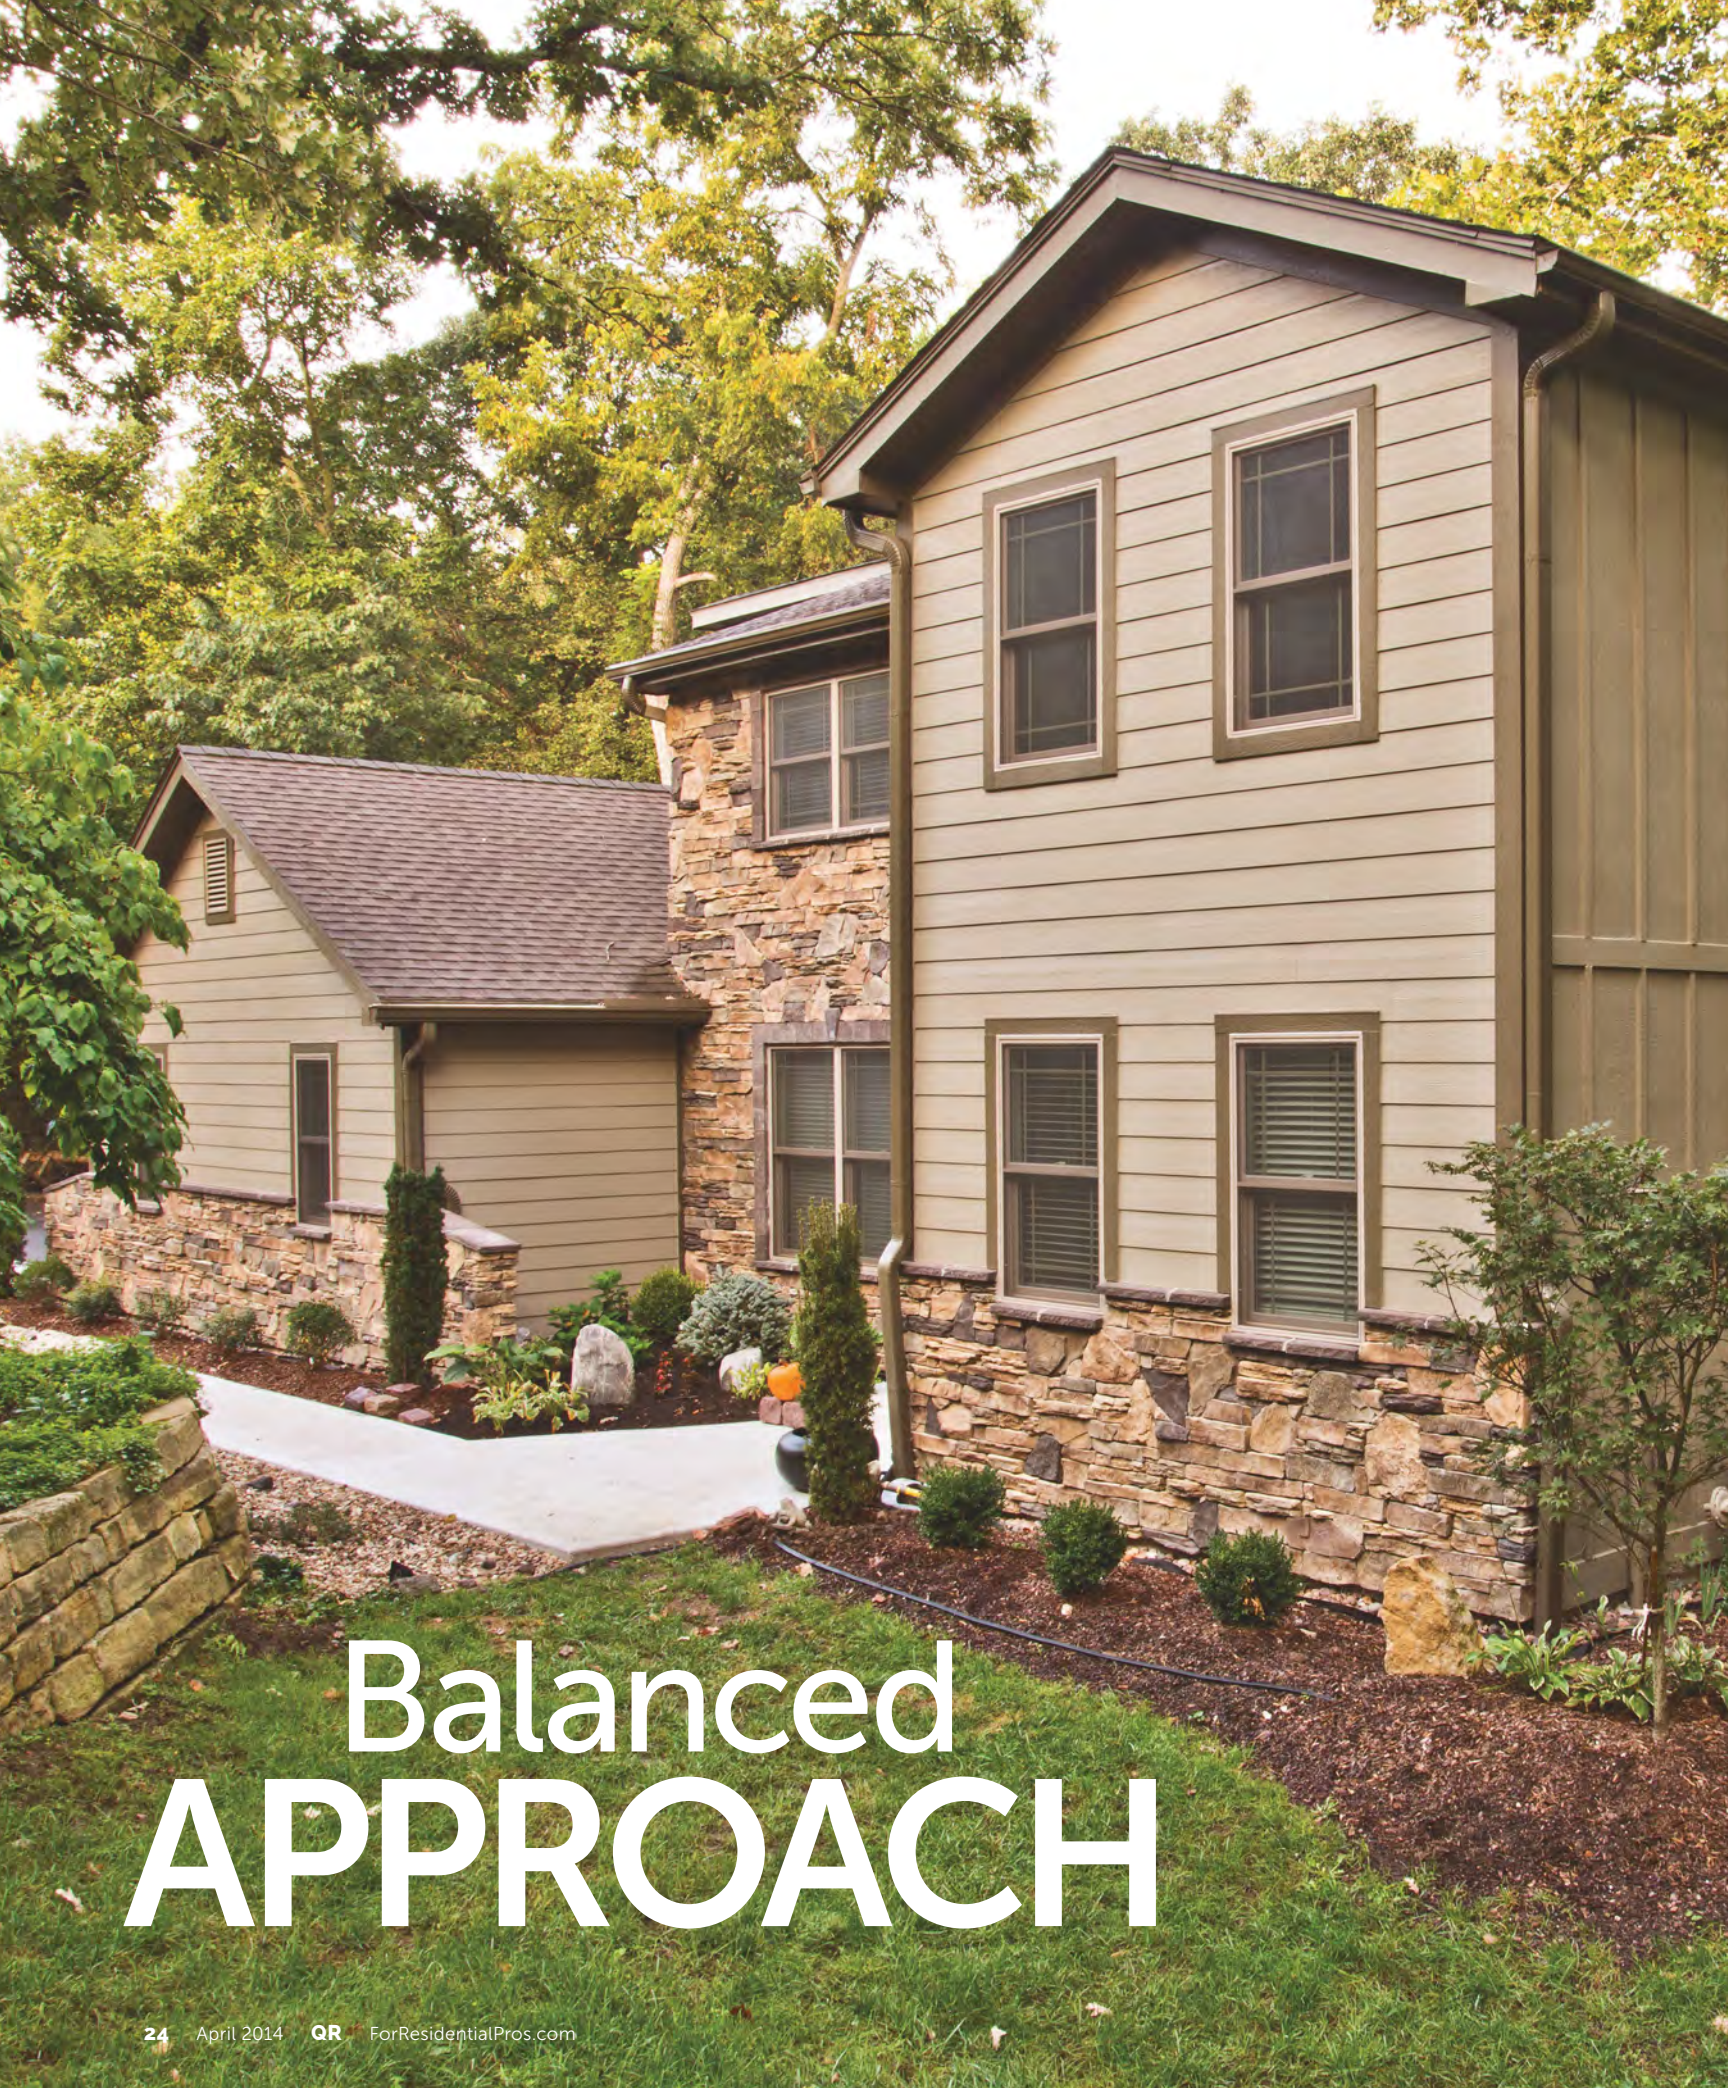
After

This total exterior face-lift encompassed work on windows, flashing, siding and more.

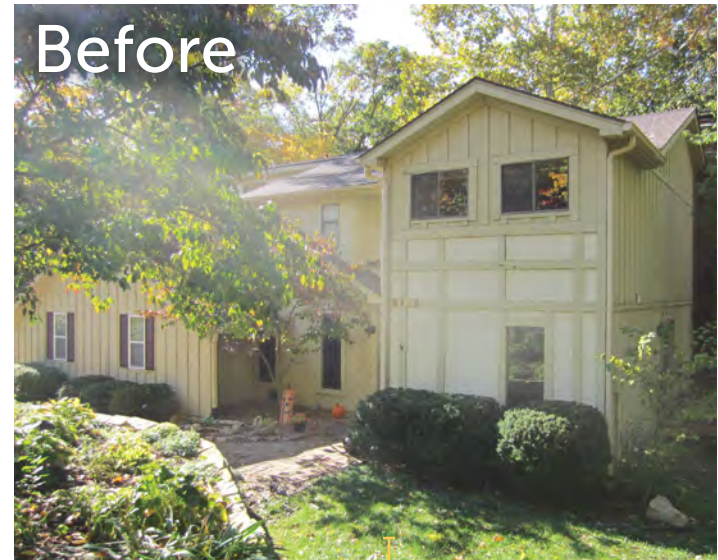
The existing house suffered from window placement that was visually imbalanced.

Set in a 1974 neighborhood development built with no preconceived house plans, all of the homes were tailored to what the original owners desired. To re-balance the home's appearance, the contractor resized 10 out of the 14 windows that were replaced.

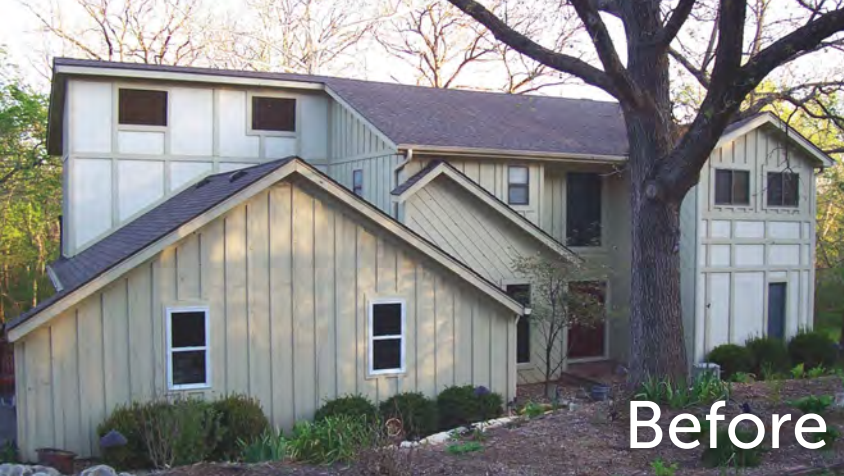
Before

The garage also underwent a face-lift to maintain visual consistency as one approaches.

The garage façade also benefited from the remodel. Originally, the owners planned to redesign only the front of the house, but the new façade is visible from the driveway and Christie championed the

need for visual consistency as one approached the home. As a result, the garage façade also received new horizontal siding and a new window. The front façade had an oversized wall on each side with the roofline jutting out an additional 4 ft. to cover the sections of wall. This created 6 by 6 ft. of wasted space near the front door that blocked natural light into the home and an odd exterior treatment at one corner of the garage. The protruding wall was cut down to the foundation, and the

extraneous sections of roofline from each side were removed. Then, stone wing walls with custom-fabricated steel brackets were added for long-term structural support.
